Manor Park

Sports Pitch Feasibility Report

Date of Visit: 9th November 2021

Visit Objective: Initial site appraisal

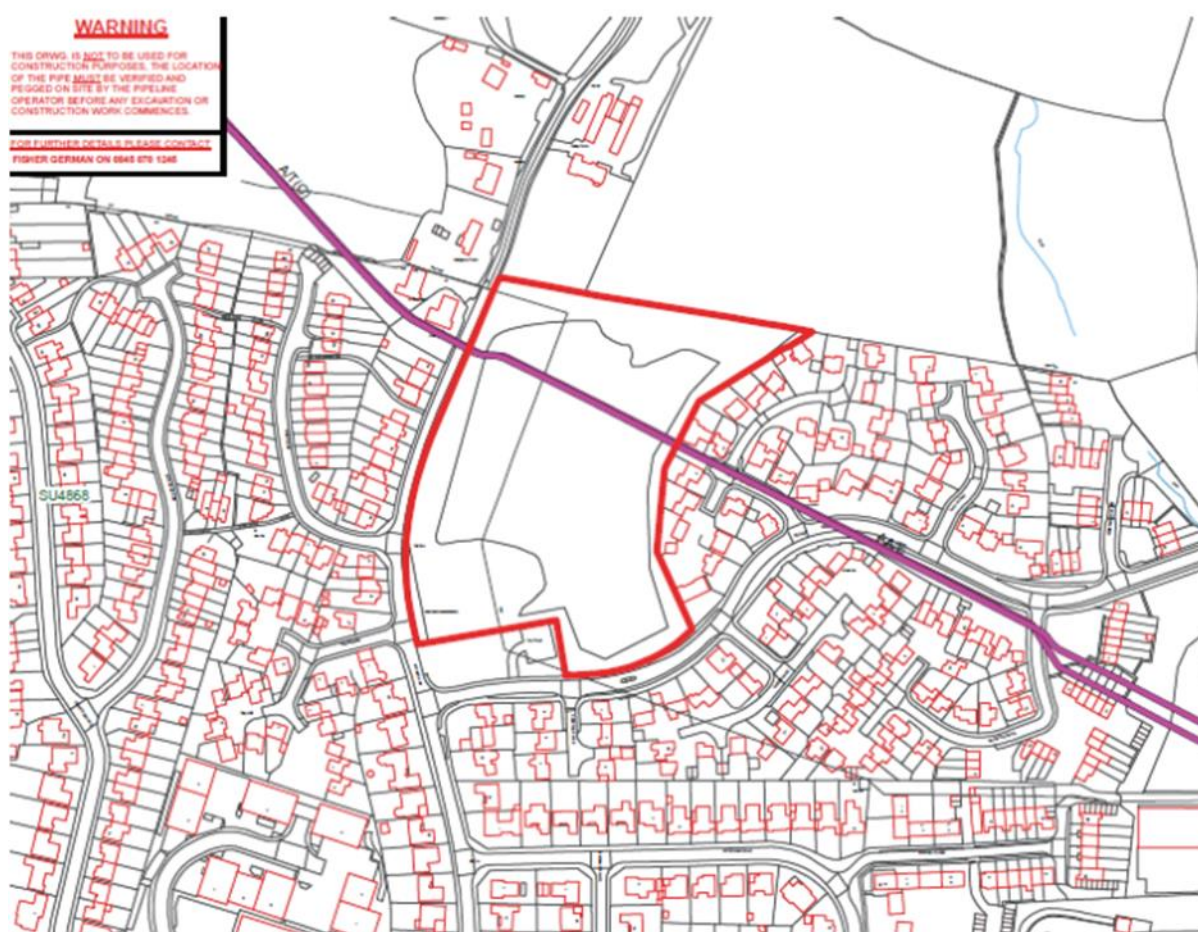
Figure 2 Indictive location of pipeline in purple

One utility service which was confirmed was an A/AE oil pipeline and a A/TC oil pipeline. STRI mapped the approximate surface location of the oil pipes during the topographical survey. STRI carried out a meeting with Exolum, who operate the pipeline. The pipes are noted to be approximately 1 m under the surface and have 8- and 10-inch pipe diameters. These oil lines were noted to be running to Heathrow. It was noted one of the pipes may in fact be unused by there is no way of knowing unless a trial hole excavation was carried out. To do this a CAT scan would need to be completed prior to any excavation. It is possible to construct over this pipeline, however usually 750 mm cover is needed. If less cover is needed for an earthworks operation extra measures/ control will need to be put in place. Exolum stated that pipe crossings with machinery should be limited as much as possible and should be coordinated that traffic is only crossing the pipe at one location. This is a buffer zone which is 3 m either side of either pipe (6 – 7 m in total) where extreme caution needs to be taken and Exolum will need to present while working in this area. To divert the pipeline around the park would cost approximately £20,000 per m per pipe¹ (2 pipes).

- Another limiting factor of this site is the oil pipe running from east to west in the northern part of this site. 750 mm cover must be maintained over these pipes when construction is taking place. Exclusion need to be present when any works are been carried out within the buffer zone. Crossings of the oil pipelines are restricted to one designated area.

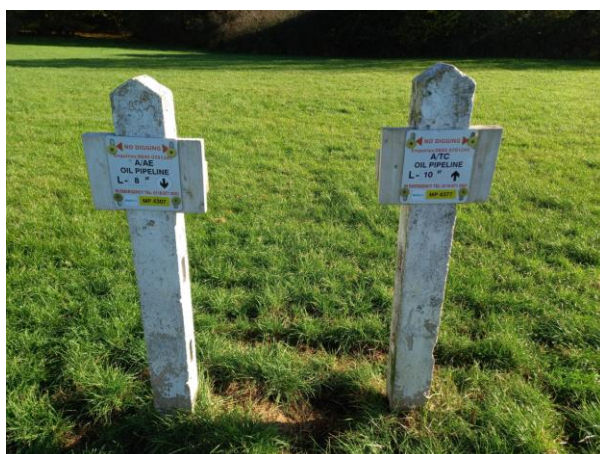
Photo 5: Surface location of oil pipes

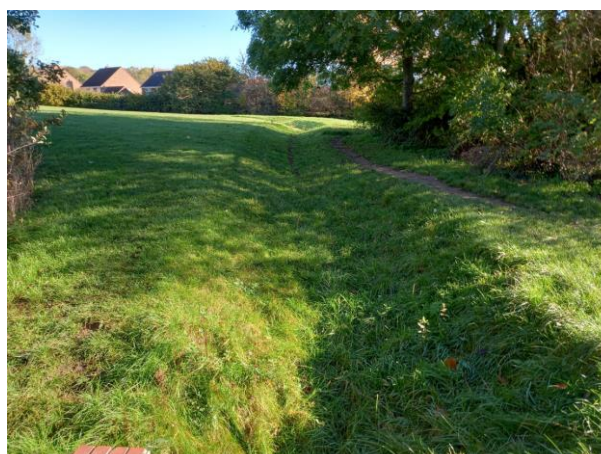
Surface evenness within the area under examination was generally good with few if any high spots or undulations on the platform, although the gradient was quite steep (1:21). It should be noted there was an open drain running from the south-east to the south (swale/soakaway), which affects surface evenness in that area.

Overall, there were slight variations in firmness across the Site. It was noted along the east wing and south-east corner was holding a lot of water. Before entering an open drain, which runs to a large water basin in the south/south-west corner. It should be highlighted that the Site investigation was carried out in November.

Photo 6: Open drain

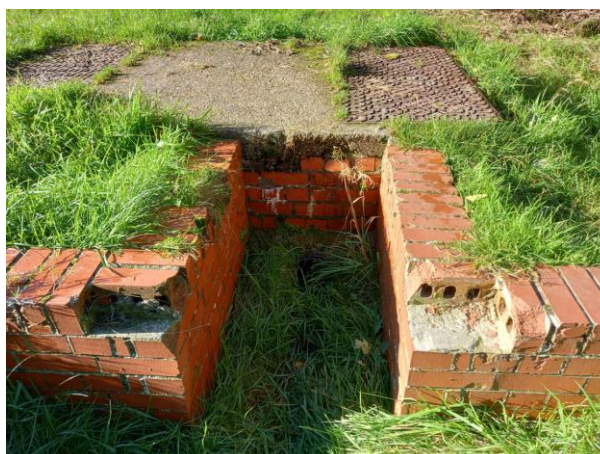
Photo 7: Culvert drain

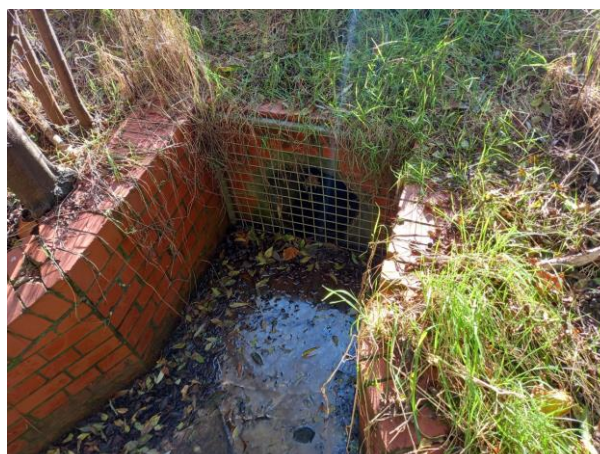
Photo 8: Outlet of culvert drain into basin

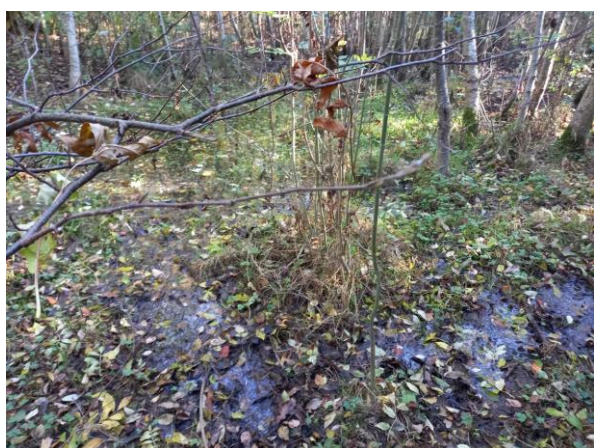
A prominent feature of the Site was the existing large water basin in the south-west corner. The Site was noted to be on a flood plain. The basin contained water at the time of the visit. There were no other viable outfall locations observed during the investigation.

- There is no known outfall option which means the water will have to be retained and disposed of onsite using a soakaway. There is an existing large water basin in the south-west corner for attenuating water. It is unclear this was created as a soakaway. With that said soakaway/percolation testing will need to take place.

Photo 9: Large water basin in SW corner

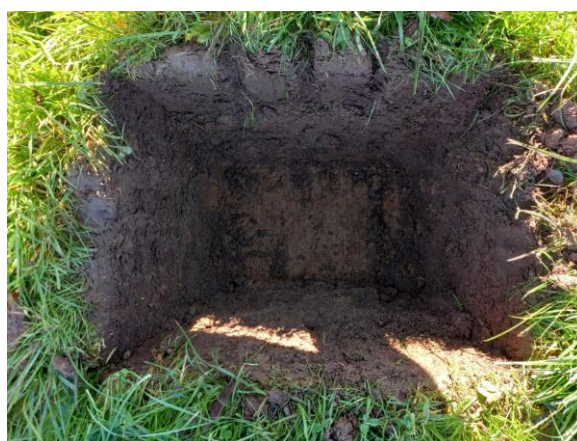
Dark-brown, easily consolidated clay loam topsoil to 330 mm depth. Roots to 160 mm depth. Clear interface between the topsoil and the subsoil, which was a yellow clay with increasing clay content with depth. Depth reached 450 mm. There were frequent stones and white gravel observed within the topsoil profile which were 30 mm in diameter. Earthworm activity was high.

Photo 10: Test pit 1- topsoil 330 mm deep

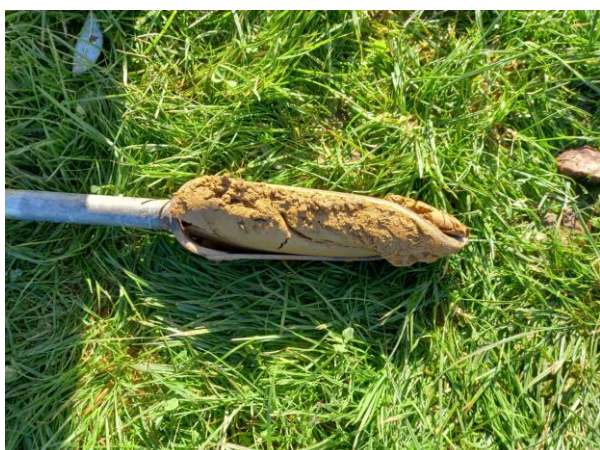
It can be anticipated that the infiltration rate of the Site subsoil will be very low.

Photo 11: Subsoil TP1

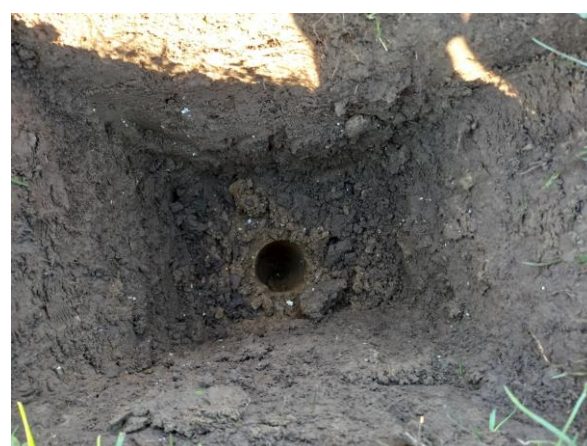
Again dark-brown, shallower topsoil was noted at a depth of 270 mm. Roots to 150 mm depth. Clear interface between the topsoil and the subsoil which again was a similar yellow clay. Depth reached was 400 mm. Mixture of gravel and white pebbles along with no worm activity noted.

Photo 12: TP3 – topsoil 250 mm deep

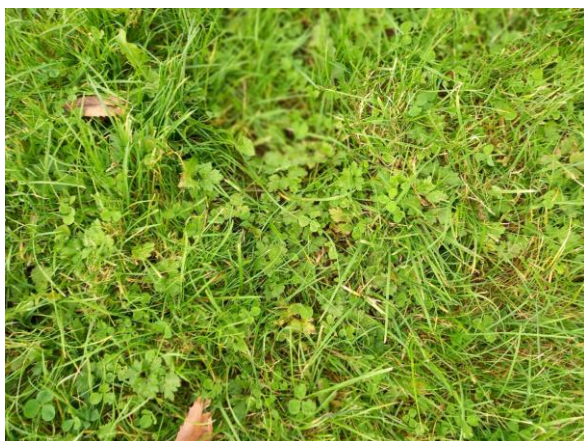
At the time of the investigation, the Site and surrounding area was well grassed, the turf being dominated with perennial ryegrass, along with other weed grass species such as annual meadow-grass, Yorkshire Fog and minor fescue sp. Significant broad-leaved weed populations were a common theme throughout the area with plantain, clover and buttercups. At the time of the visit the grass height was roughly 100 mm. The Site was surrounded by semi-mature/mature trees. It was noted that these trees/hedgerows have not been maintained and have grown over. The swale contained water at the time of visit.

Photo 11: Existing Vegetation

- There is sufficient space to accommodate a full-size rugby/football pitch while adhering to Sport England guidelines (94 x 70 m).
- The Site currently has a range of grass and weed species. Before any upgrades to any pitches the existing vegetation should be thoroughly killed off and removed to enable the pitch development works and to prevent weed re-infestation.

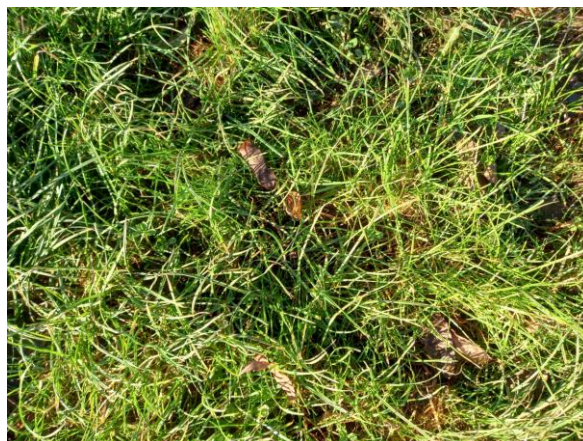
Photo 11: Existing vegetation

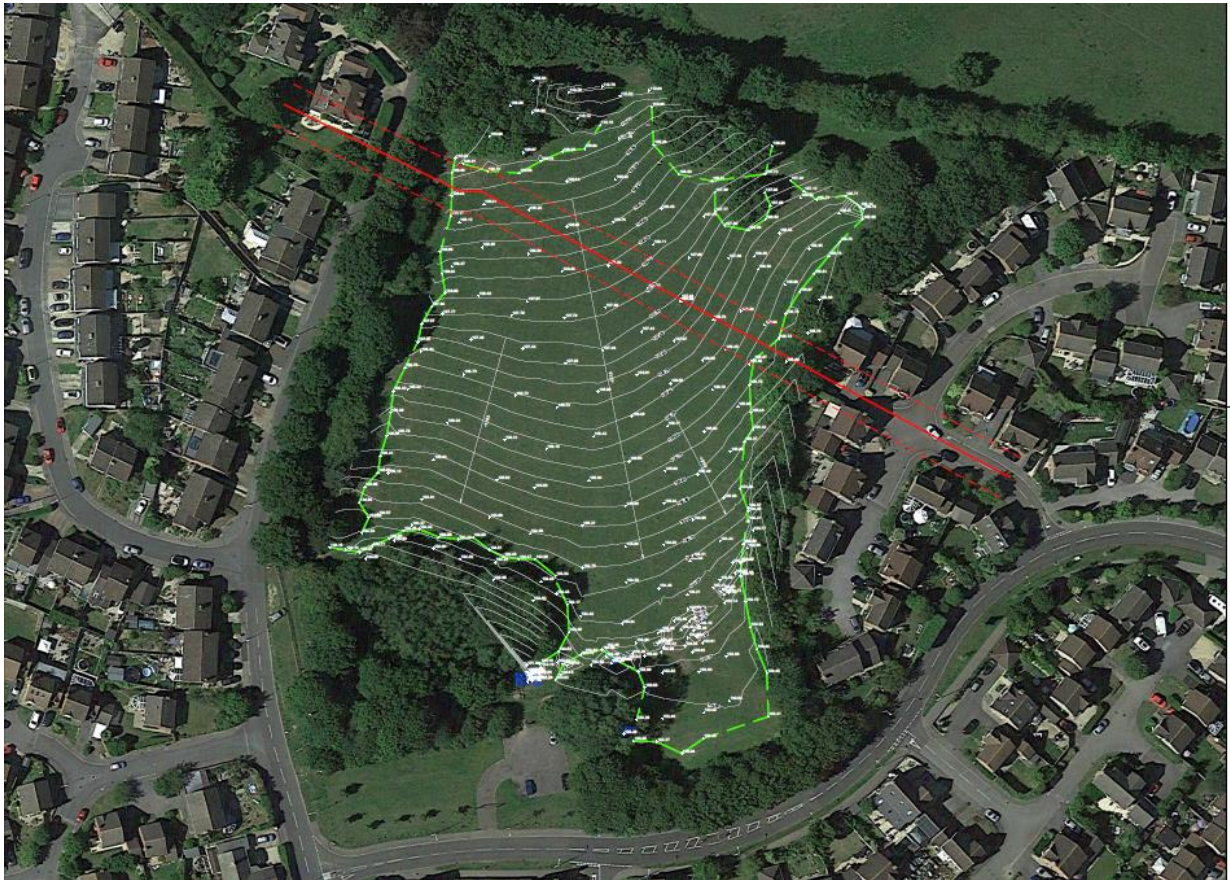
Appendix 4 – Topographic Survey

The Site has a pronounced, roughly diagonal fall from the north-west corner to the south-east corner.

The highest ground levels were observed in the north-west corner of the Site (110.79 m). The lowest ground levels were observed in the south of the Site (103.19 m).

Based on the topographic information as reviewed by STRI, it can be confirmed that a major cut and fill earthworks operation would be required if any developments were to take place on this area to create a pitch platform with a uniform grade to meet Sport England Requirements cross fall. There is a 1:21 fall across the Site.
