## Home to School Transport – Assessment of on-Highway Walking Route

School	Tull Way (Generic report)
Overall route	The crossing point on Tull Way at its junction to the A4.
Road name(s)	Tull Way.
Speed limit	40 mph
3 year accident record	Between 01 November 2010 and 31 October 2013, there has only been 1 recorded injury accident in the vicinity of the Tull Way crossing point. This occurred in November 2010 on the roundabout when a car exiting Tull Way failed to give way and struck a motorcycle travelling from Newbury toward Thatcham. This resulted in the rider receiving slight injuries and occurred outside of school hours.
Road width	7 metres
Street lighting	Yes
Footway	Yes
Footway width	2.3 – 3.0 metres
Verge to step on to	N/A
Verge width	
Visibility	Visibility is good in both directions
Traffic volume	Estimated at medium.
Traffic speeds	Vehicles are slowing for the roundabout or have just negotiated the roundabout. No surveys at this point but estimated that average speeds will be in the vicinity of 20 mph

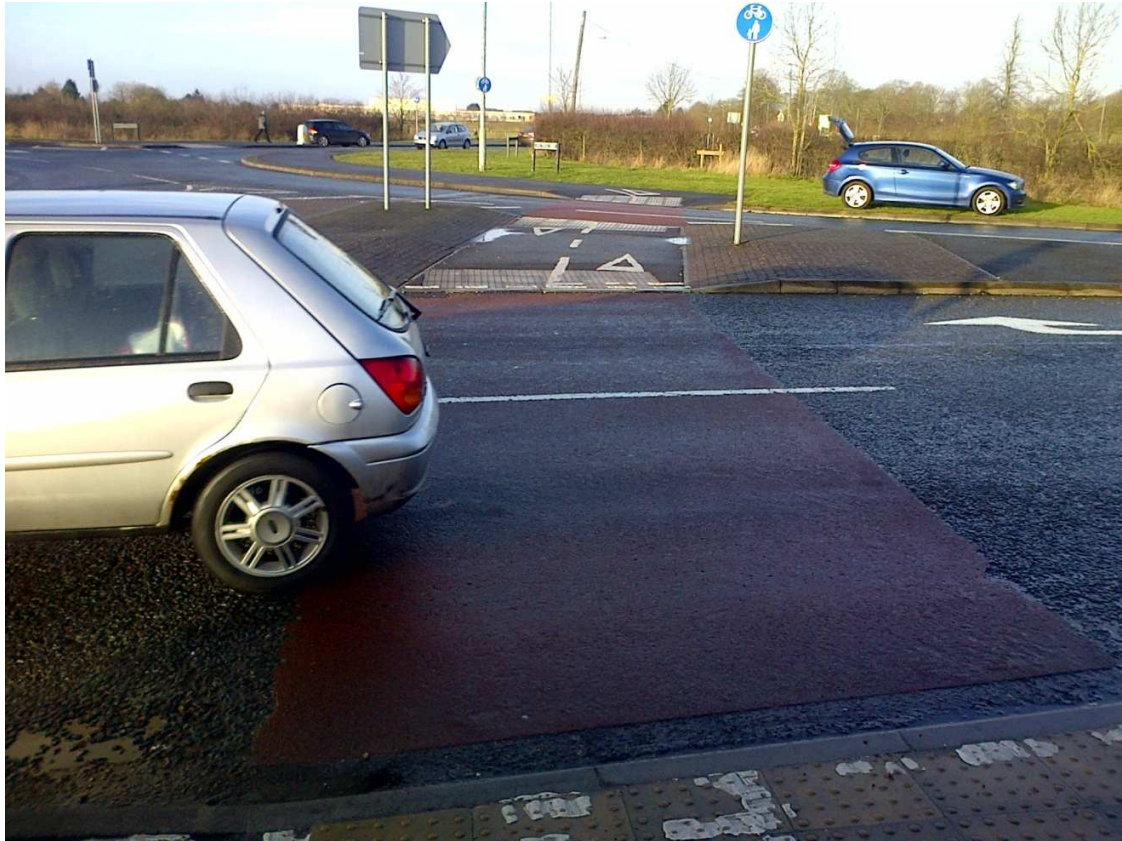
General comments	<p>The crossing point on Tull way has a large central refuge. The crossing is made in two stages. Each of the carriageway crossings is 7 metres and the southbound carriageway is split into two lanes at the entry to the roundabout. The central refuge is also 7 metres in width and provides ample storage for pedestrians and cyclists.</p> <p>This is a purpose built crossing point with a level dropped kerb and tactile paving on the crossing points. Visibility in both directions is very good.</p> <p>The crossing was assessed at 08:45 and at this time the traffic from the north appeared to be arriving at the junction in pulses. This resulted in traffic at times queuing back from the roundabout over the crossing but on all occasions this cleared quickly. So at times there may be a short wait for a gap in the traffic on the eastern leg of the crossing. The roads approaching the crossing were checked as it was suspected there may be some temporary traffic control however, all were clear.</p> <p>The Western leg had a low volume of vehicles and crossing this point was easy with very short if any wait time.</p>

Tull Way crossing point looking from the eastern side

Degree of risk (U/H/M/L)	Medium - Low
Suggested risk mitigation	High visibility jackets should be worn at all times.
