West Berkshire Council

S19 FLOOD INVESTIGATIONS

Storms Henk, Isha, and Jocelyn - January 2024

REPORT (VERSION 1) PUBLIC

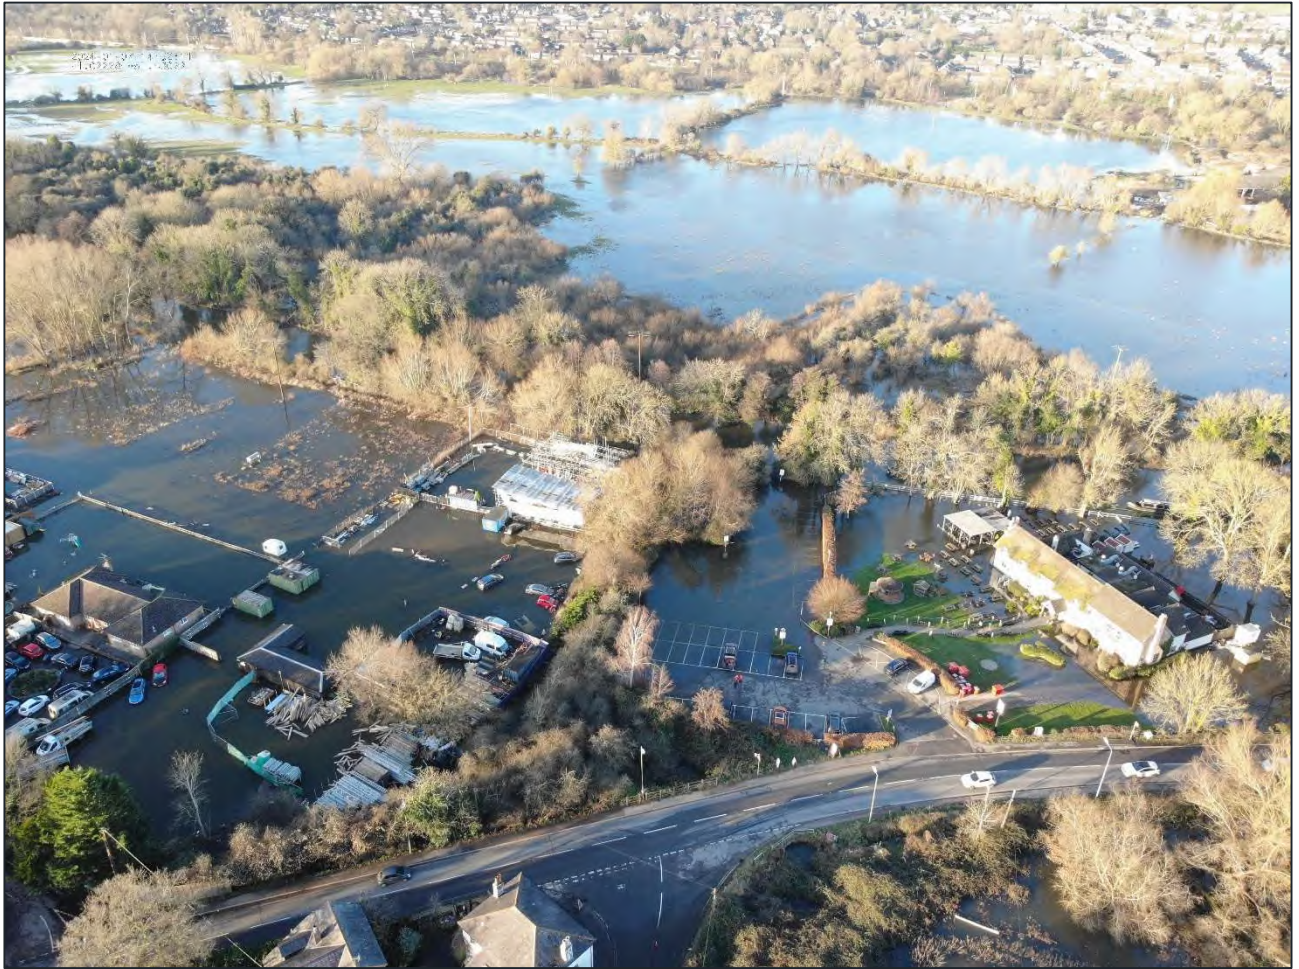
Figure 5-2 – Flooding at Burghfield

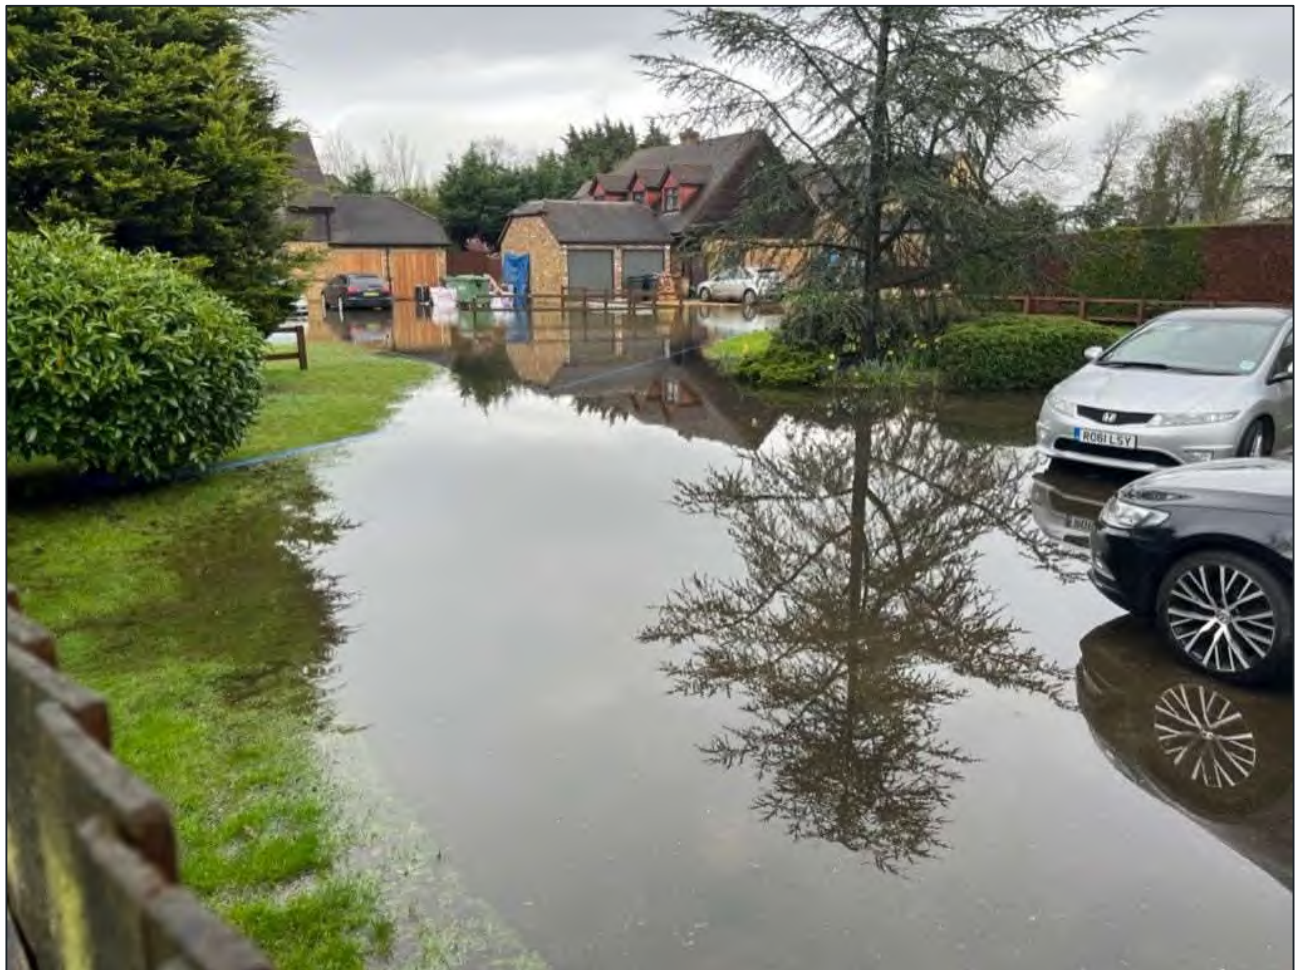
Figure 5-3 – Flooding at Burghfield Bridge Close

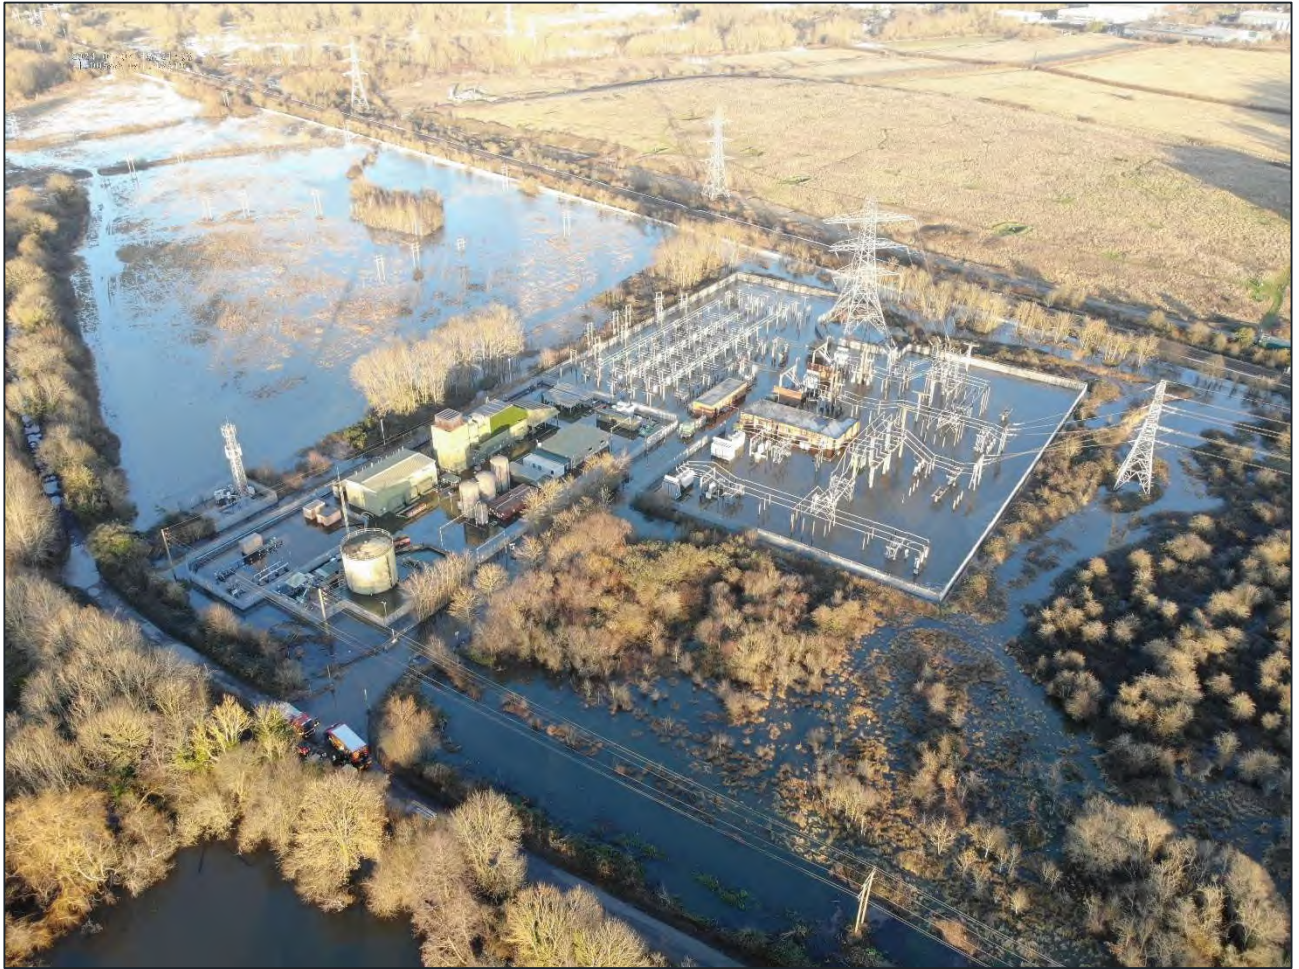
Figure 6-2 – Flooding at Pingewood Substation

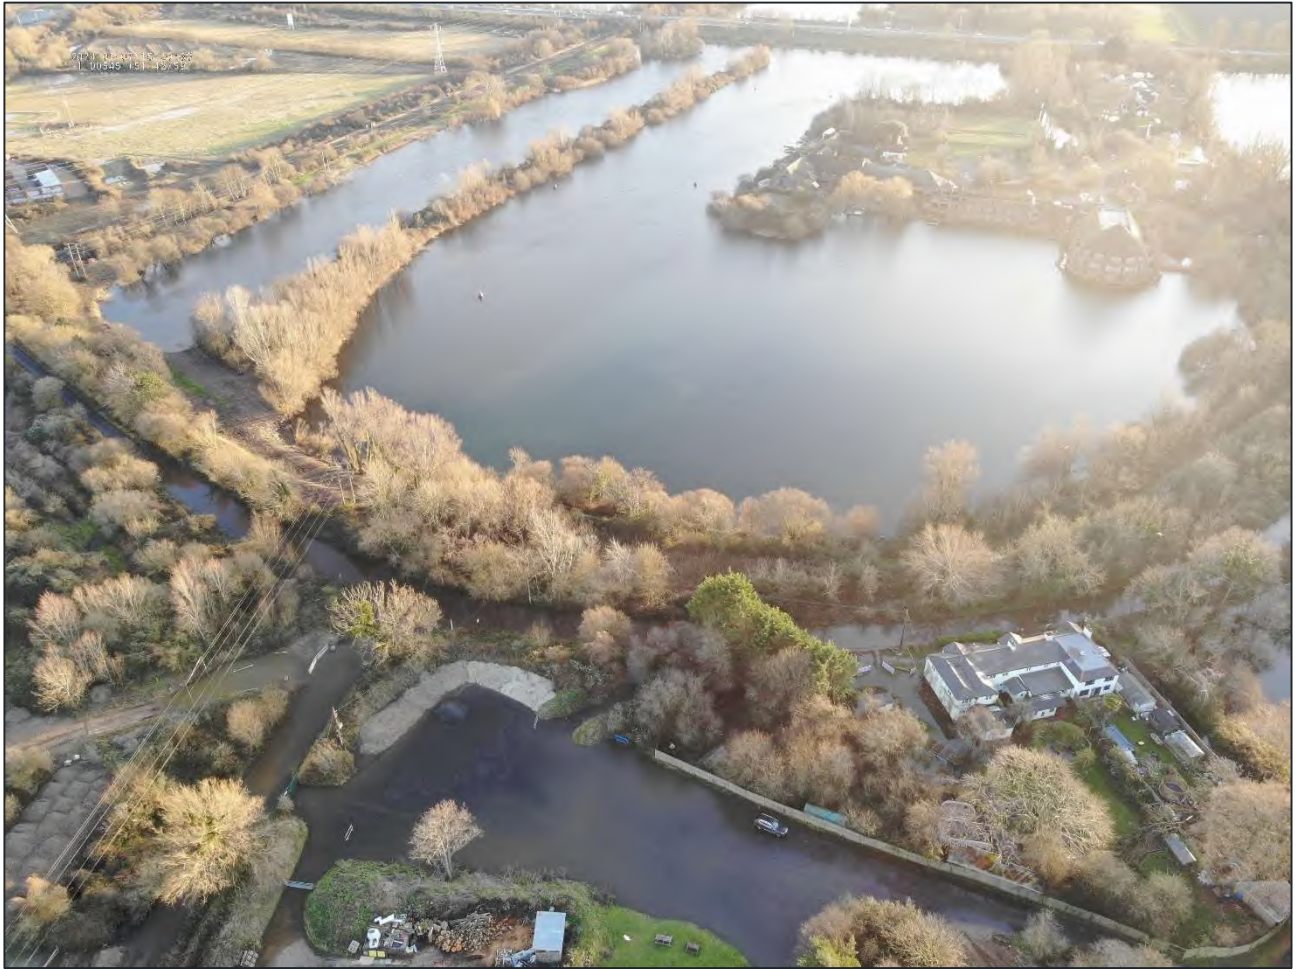
Figure 6-3 – Flooding at Kirtons Farm Road

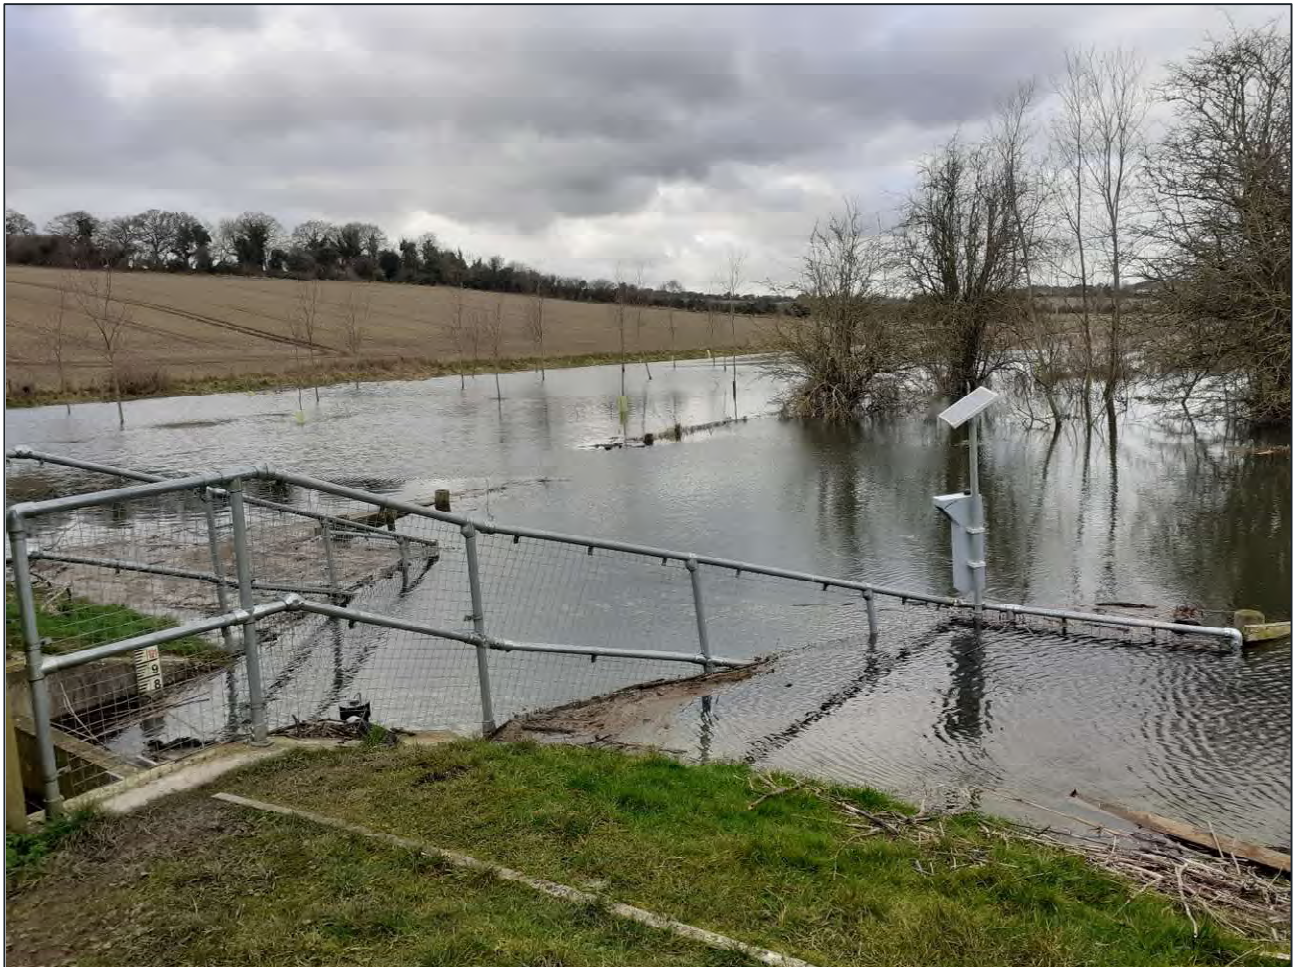
Figure 8-2 – Eastbury Flood Alleviation Scheme in operation

- 8.4.1. Eastbury benefits from a flood alleviation scheme, located along the River Lambourn, just upstream of the village. The scheme opened in June 2015 and was designed to control the amount of water flowing into Eastbury. The scheme consists of a bund running along each of the adjacent fields and a dam across the River Lambourn, with a gap on the riverbed to allow the river to flow through at

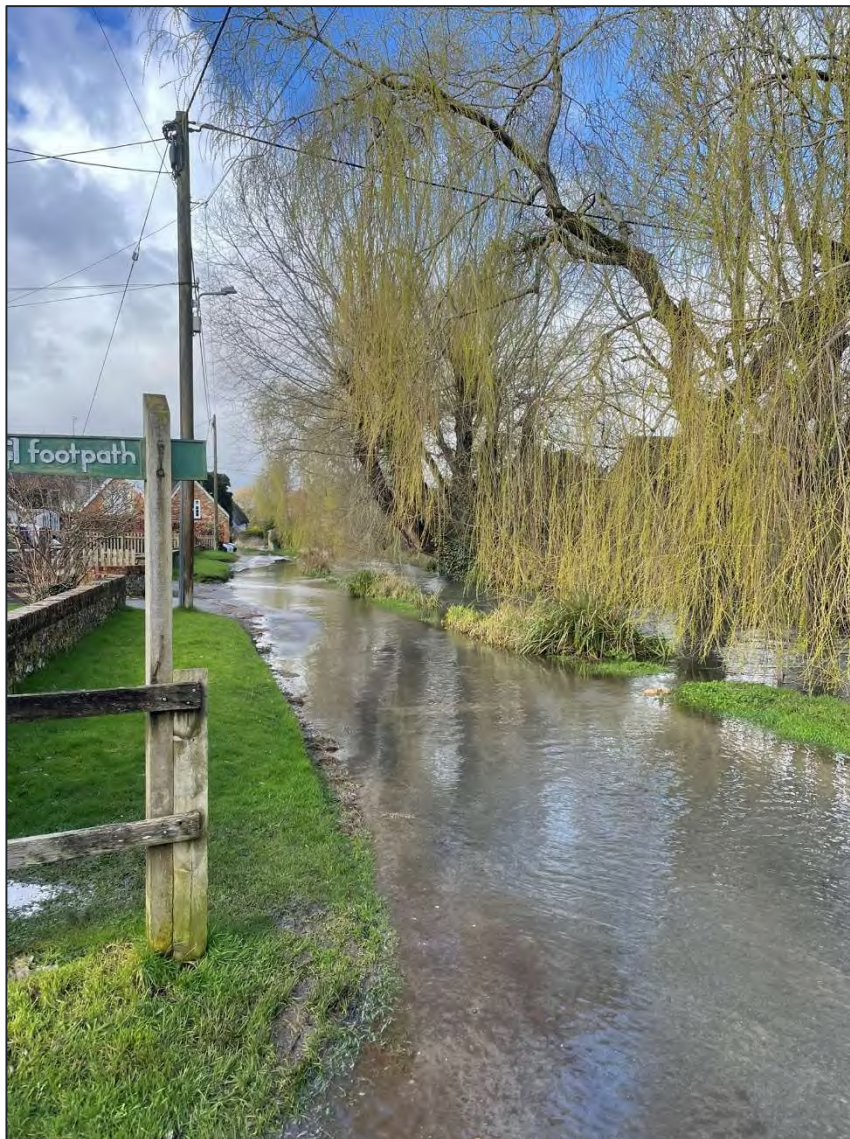
Figure 8-3 – Flooding at Back Street

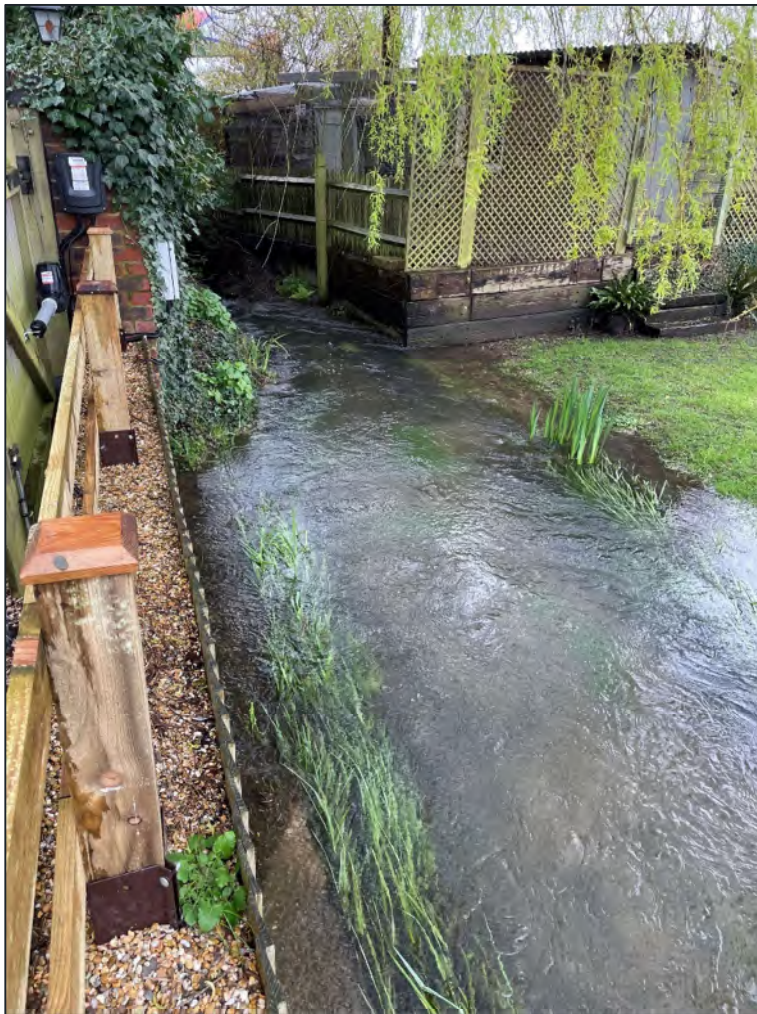
Figure 9-2 – Flooding at Great Shefford Stream

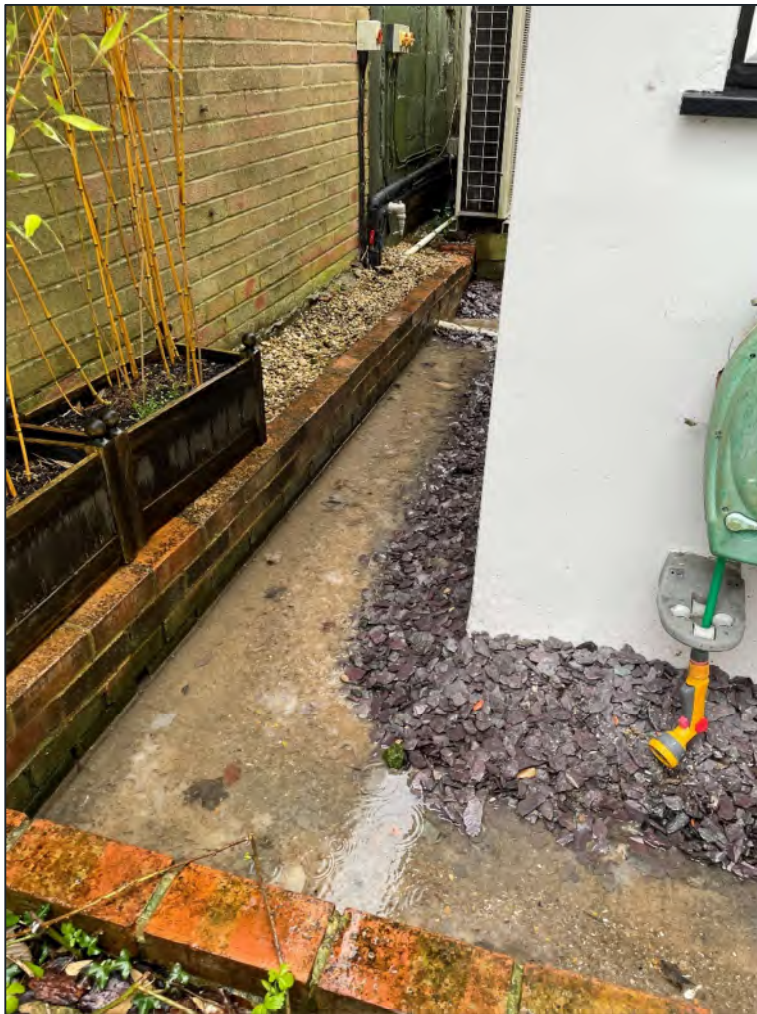
Figure 9-3 – Flooding at Wantage Road

- 9.4.1. Great Shefford currently benefits from a temporary flood alleviation scheme that takes water from the winterbourne stream running along Wantage Road and pumps it 900m before discharging it into the River Lambourn along Newbury Road. During the 2024 flood event, the temporary scheme worked as planned. The pump was switched off a week prior to WSP's visit.

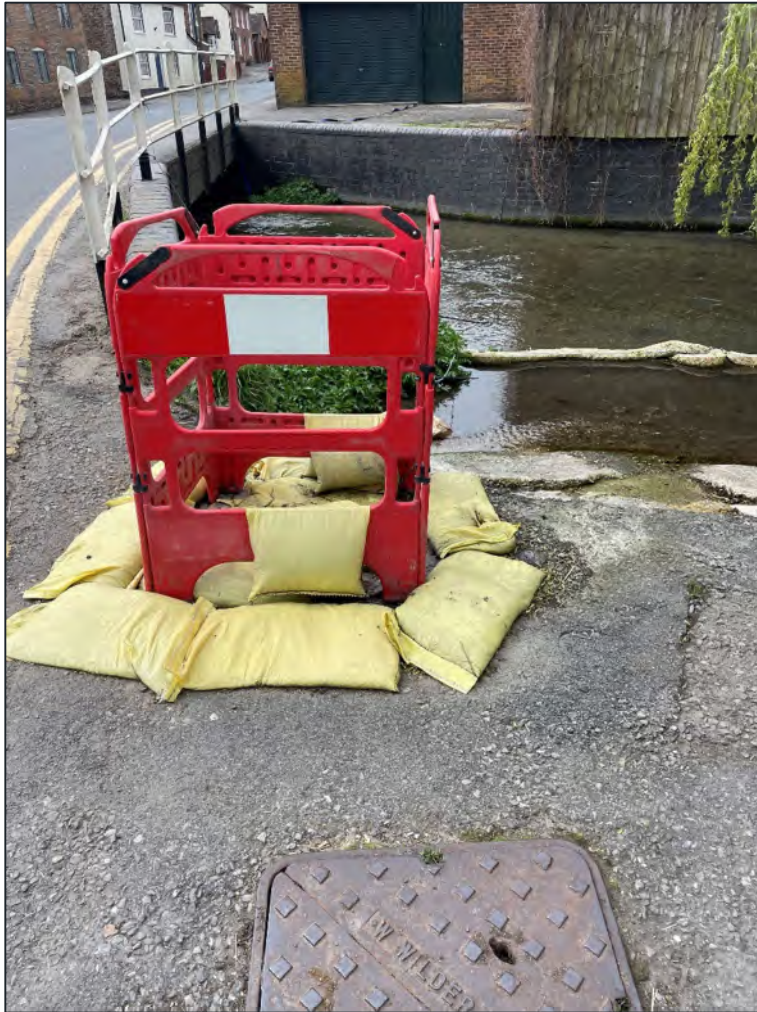
Figure 10-2 – Flooding at Wantage Road

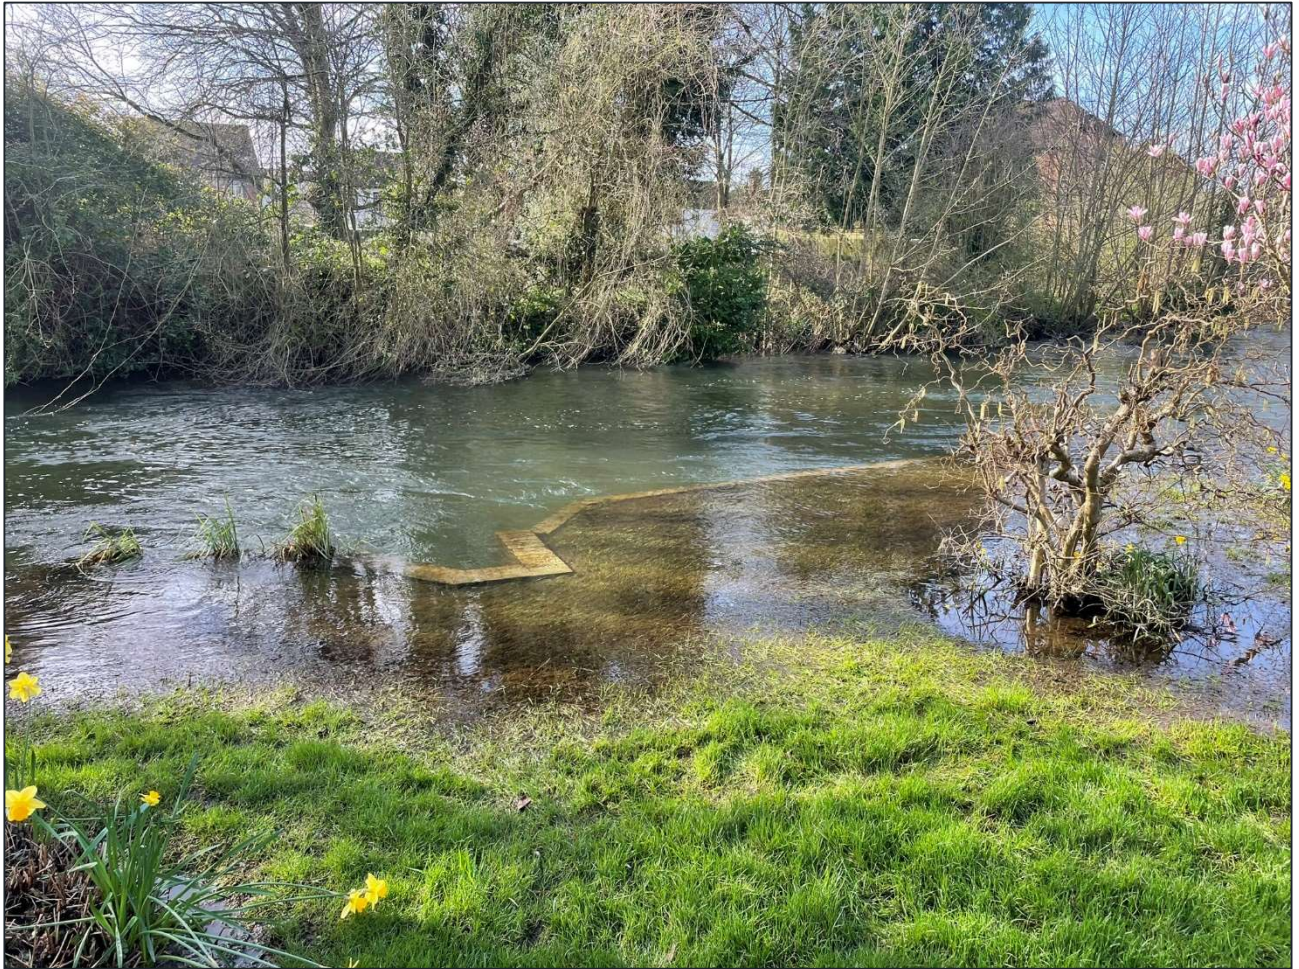
Figure 11-2 – Flooding at Swan Court

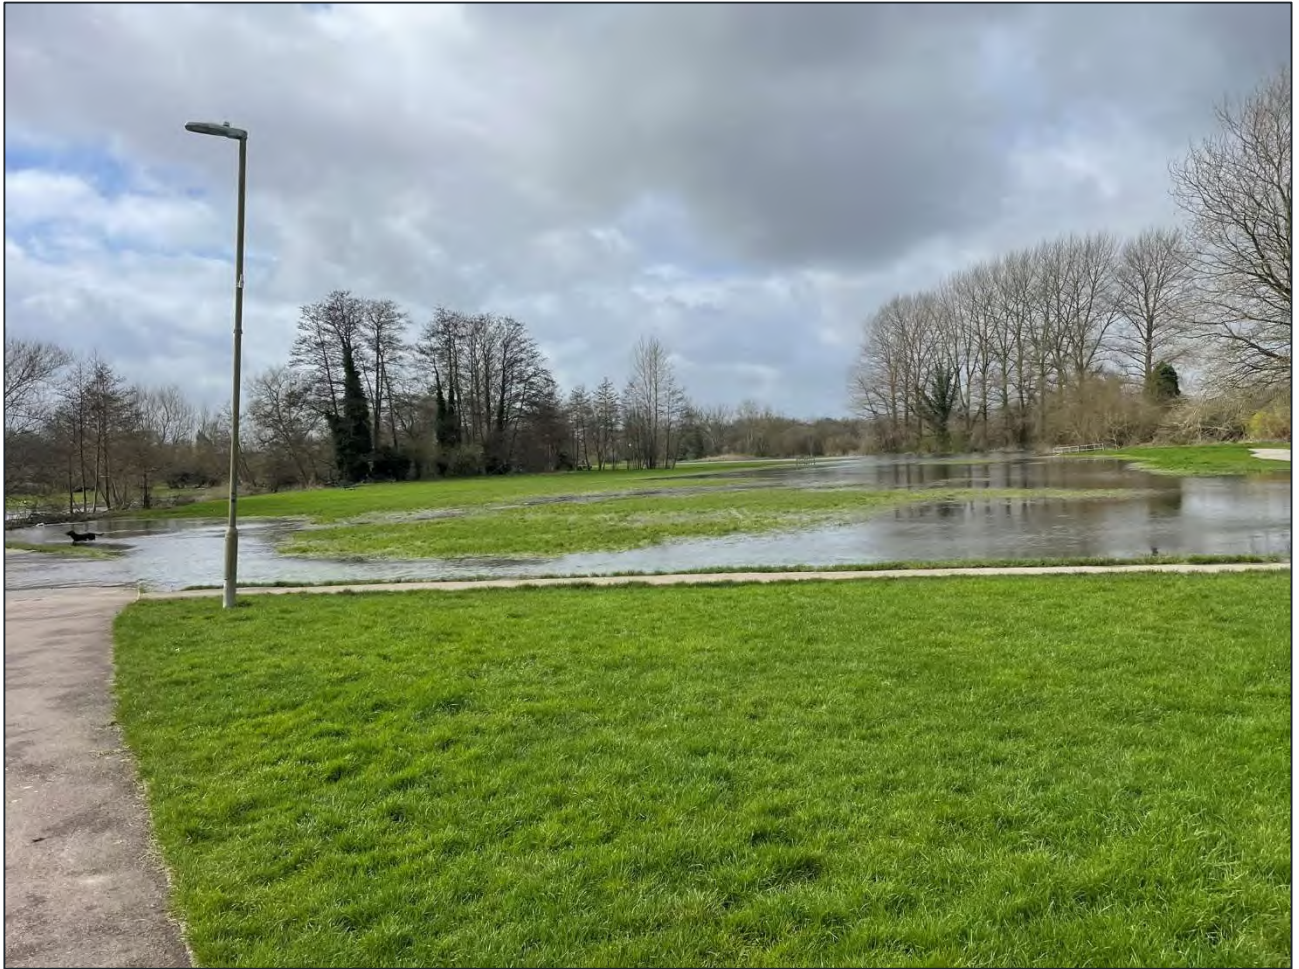
Figure 11-3 – Flooding at Northcroft Park

- 11.4.1. Northcroft benefits from two flood alleviation schemes. The first is a bund in Goldwell Field which was built in 2014 for temporary floodwater storage and to protect properties in Cleaveland Grove and Crawford Place from fluvial and above ground flooding from the functional floodplain. During WSP's site visit to Northcroft no reports of flooding to Cleaveland Grove or Crawford Place were reported, so it is assumed that the alleviation bund was successful in preventing flooding to these properties.

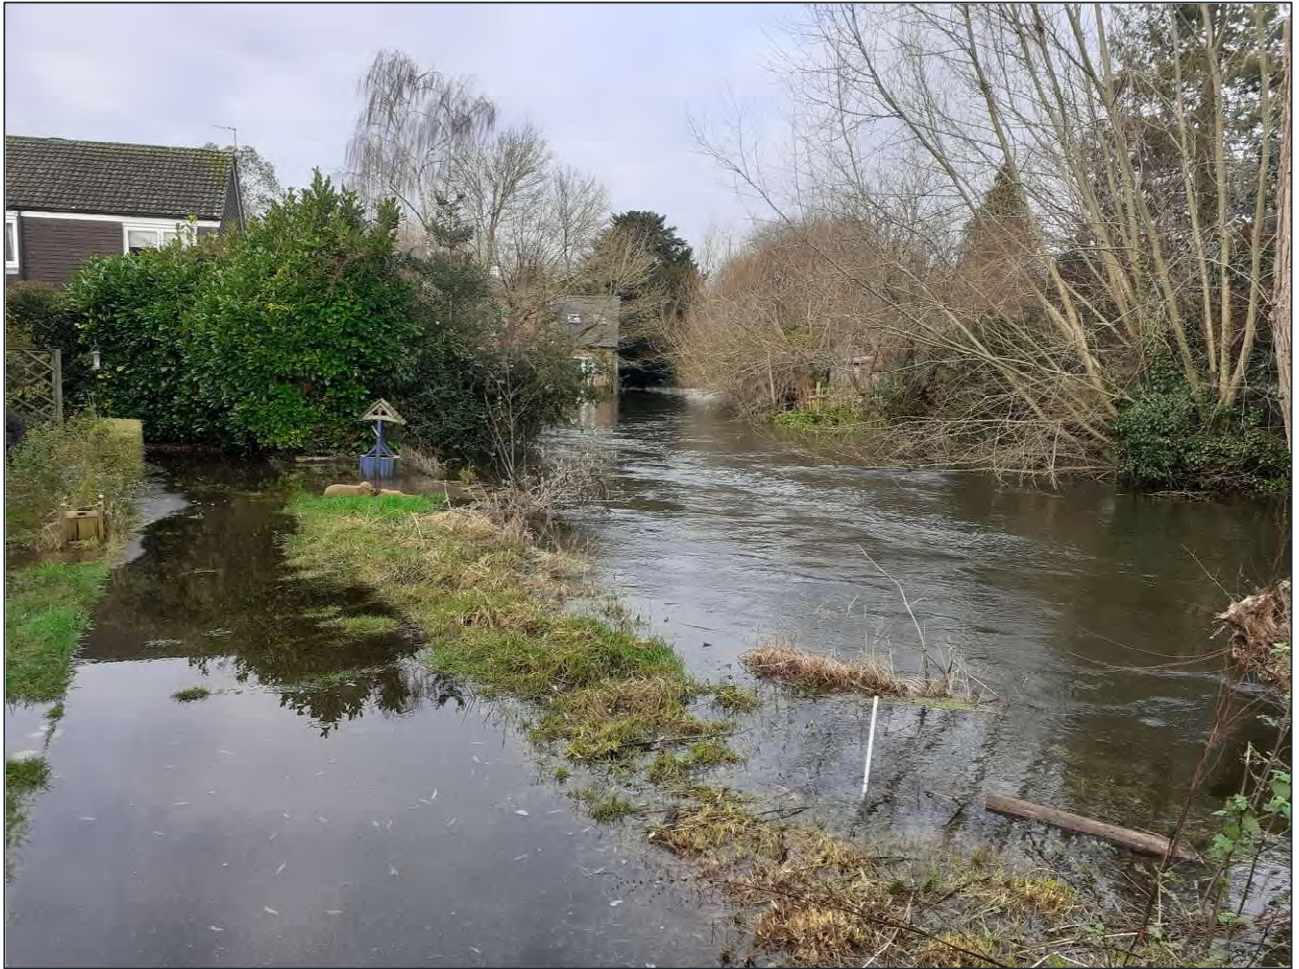
Figure 12-2 – Flooding to the North of Newport Road

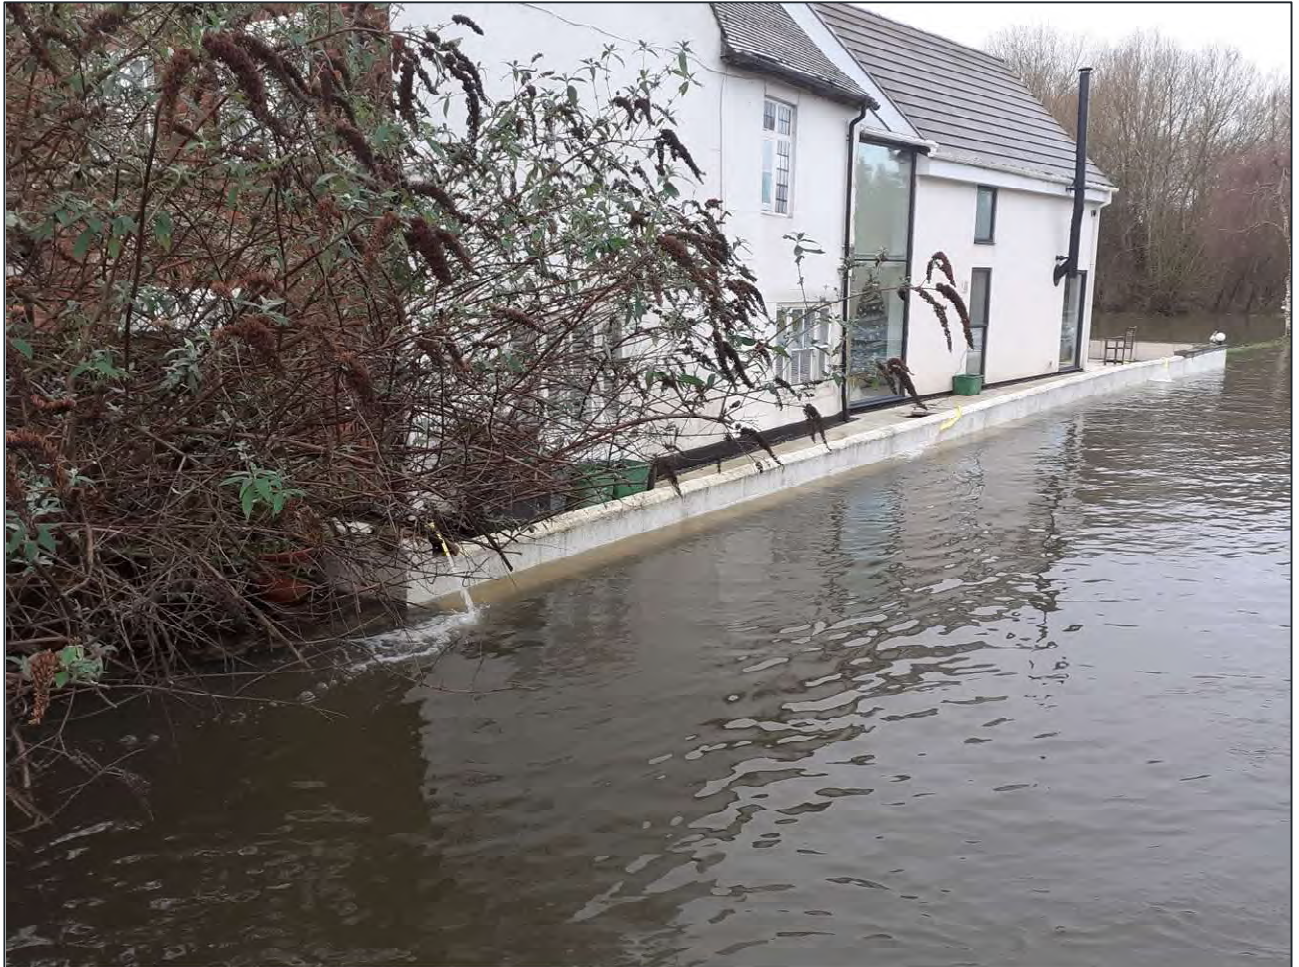
Figure 12-3 – Flooding to the North of Coachman's Court

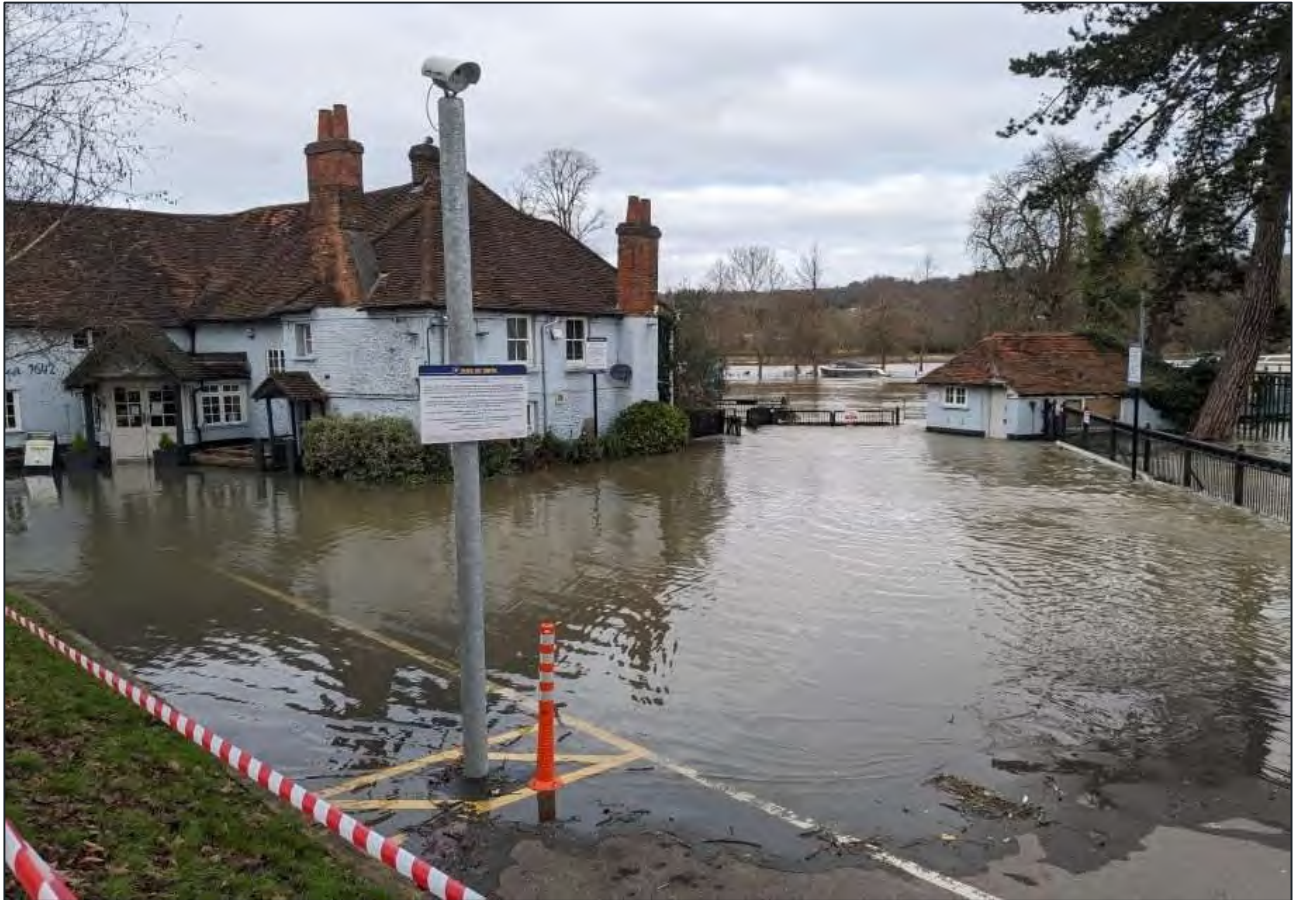
Figure 13-2 – Flooding at Shooters Hill

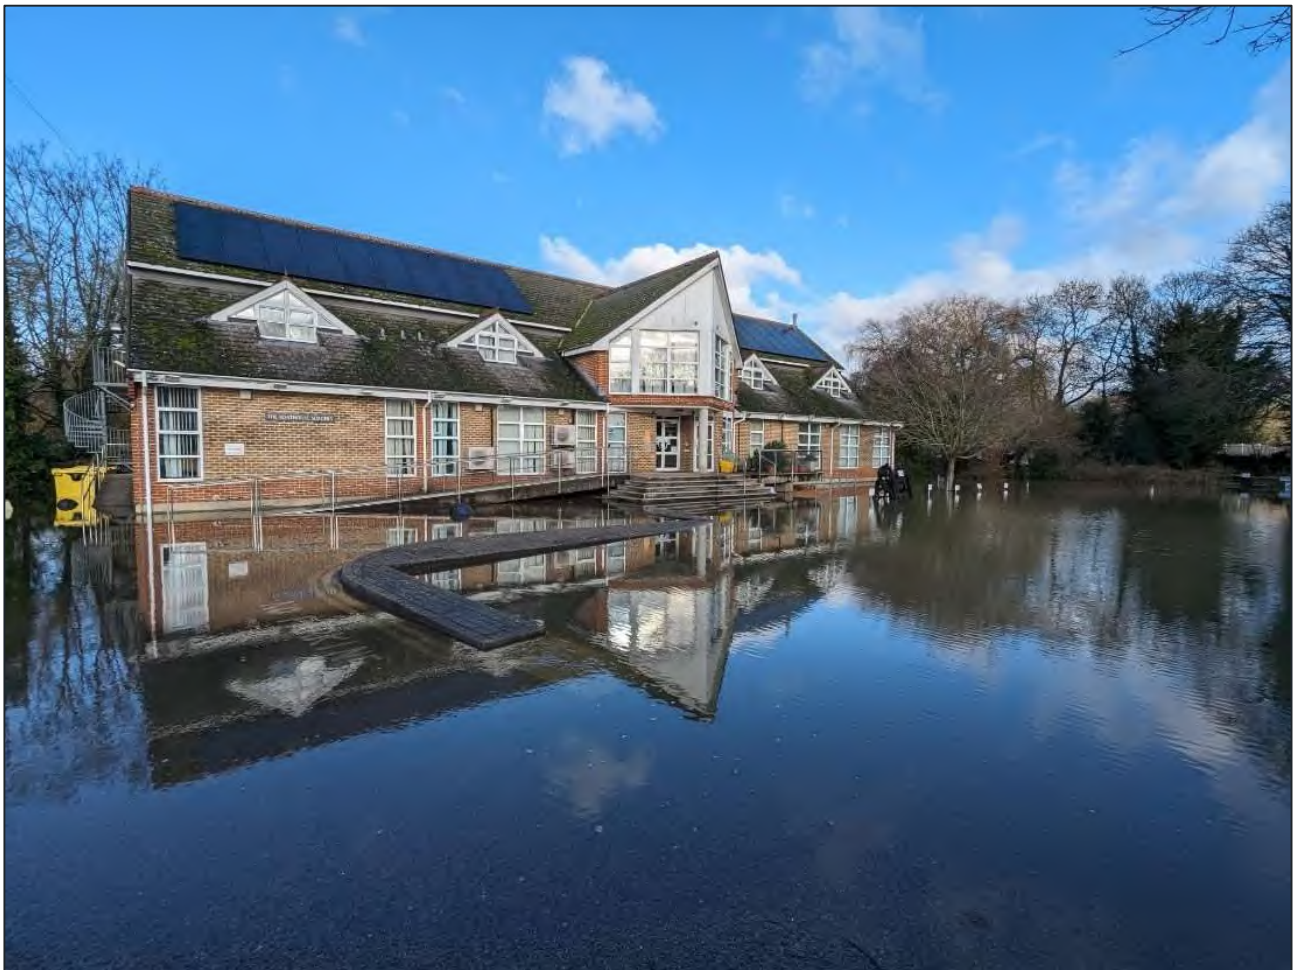
Figure 13-3 – Flooding at Whitchurch Road

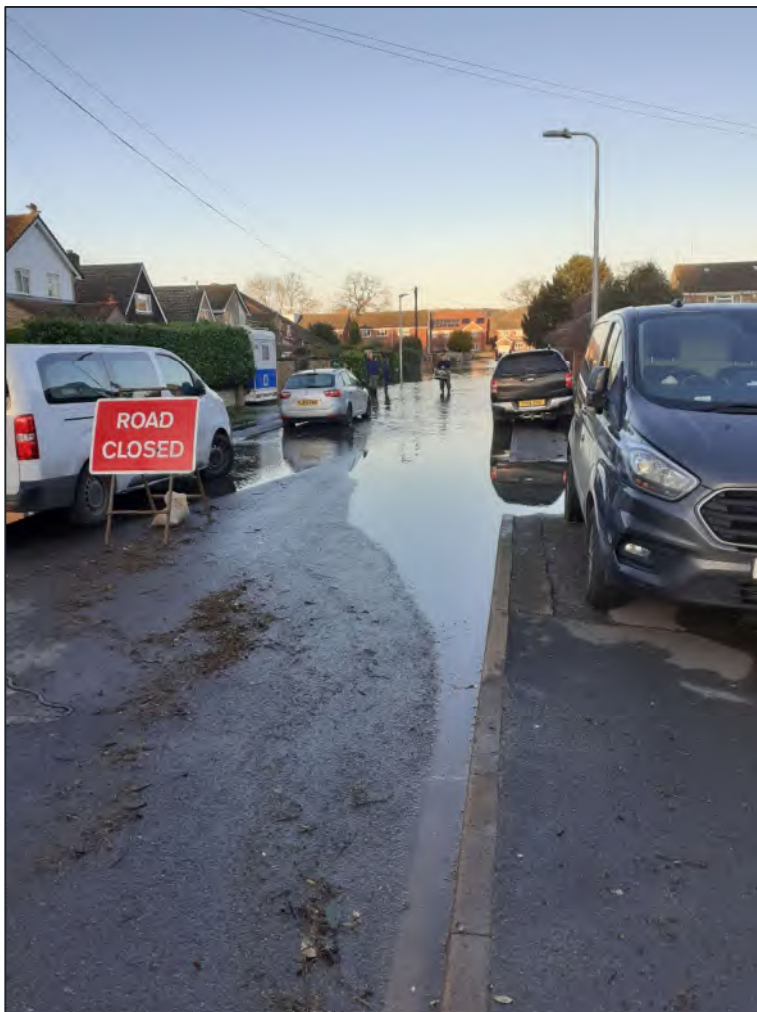
Figure 14-2 – Flooding at Purley on Thames

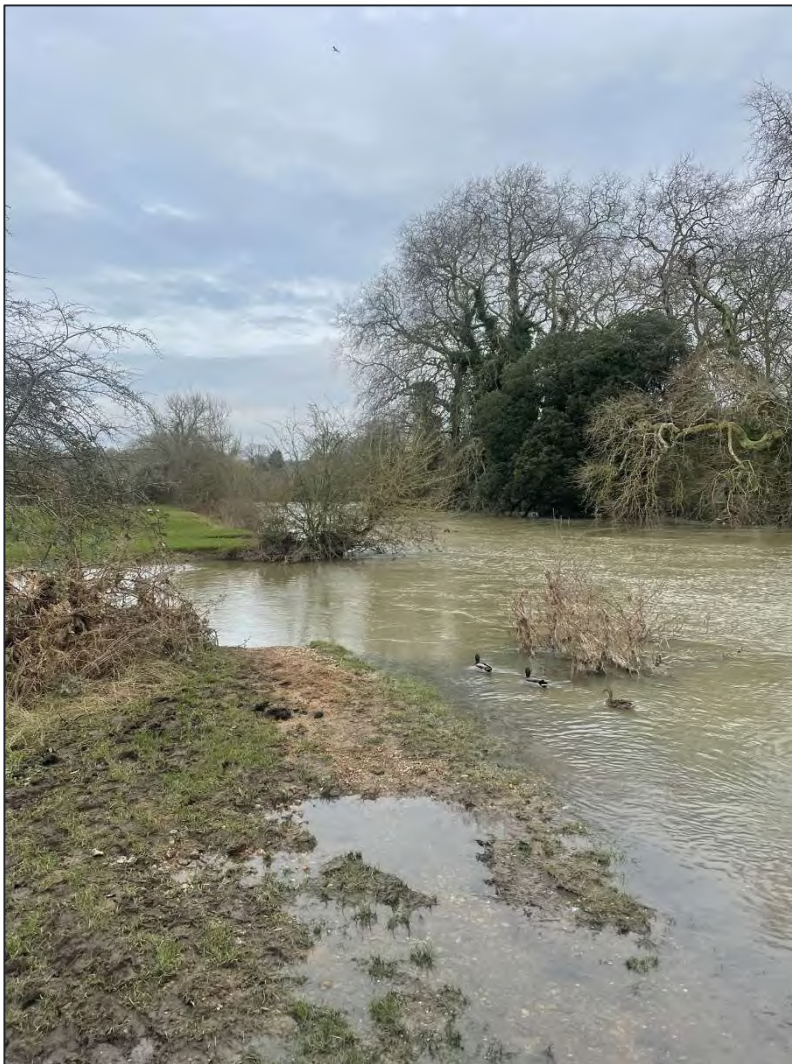
Figure 14-3 – Flooding at Blount's Meadow

- 14.4.1. Purley on Thames currently benefits from a flood alleviation scheme which was implemented in response to the 2013/14 flood event. An approximately 1.5m high bund was built in Blount's Meadow to prevent fluvial floodwater from entering the properties along Wintringham Way. Flood wardens reported that usually the bund is sufficient to prevent fluvial flooding from affecting Wintringham Way however, during the 2024 flood event, river levels were higher than the bund. As a result, two properties experienced internal flooding, ten properties experienced garage flooding, and twelve properties experienced external garden flooding.

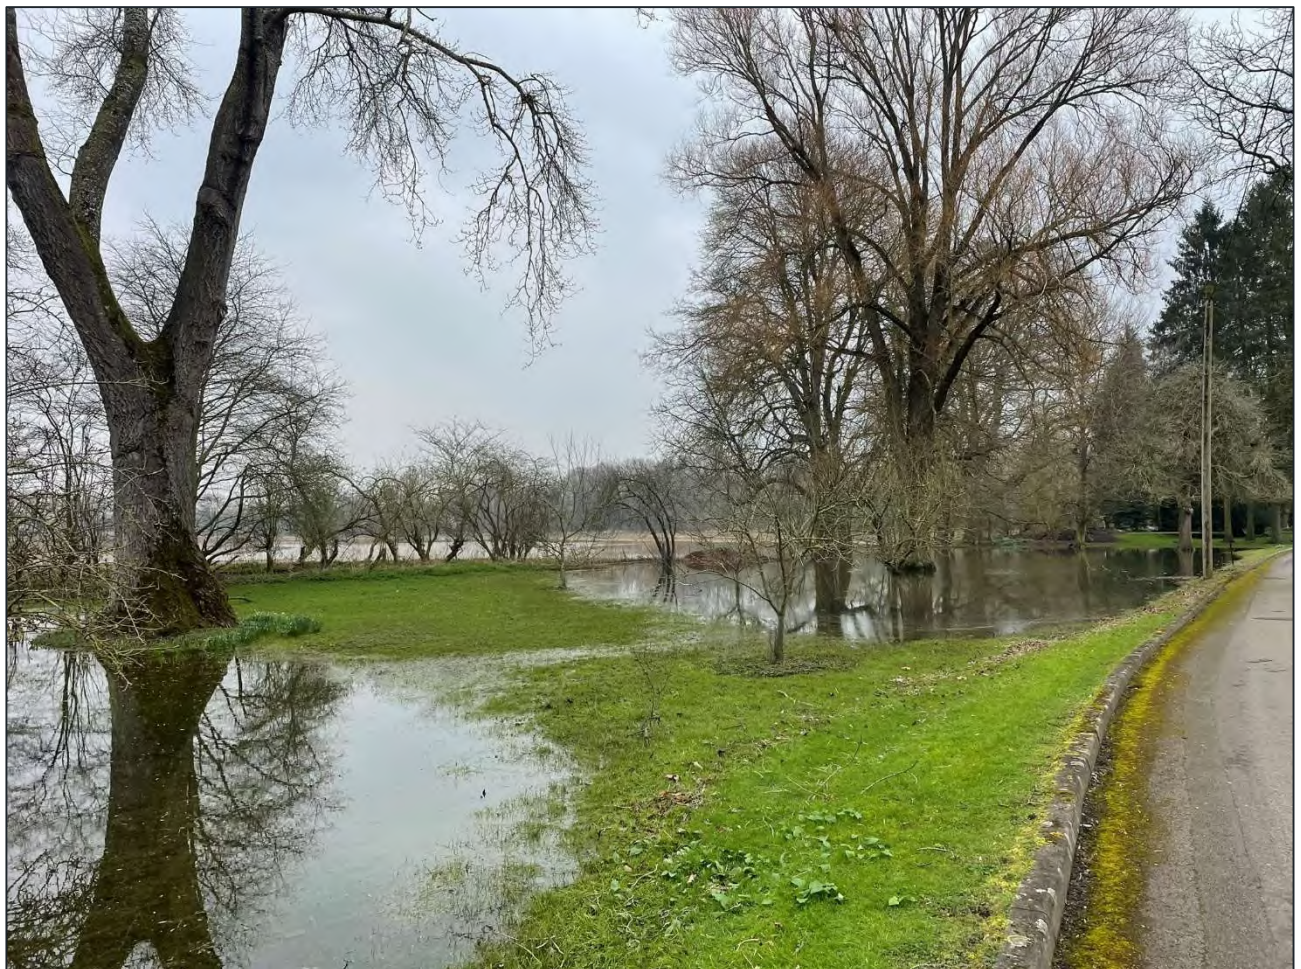
Figure 15-2 – Flooding at Cleeve Court
